A REPORT ON
AN INVESTIGATION OF THE CORROSION OF
REINFORCING STEEL IN THE OTEN WASH BRIDGE
NO. 58-277 ON ROAD XI-Imp-187-G

September, 1959

State of California
Department of Public Works
Division of Highways
Materials and Research Department

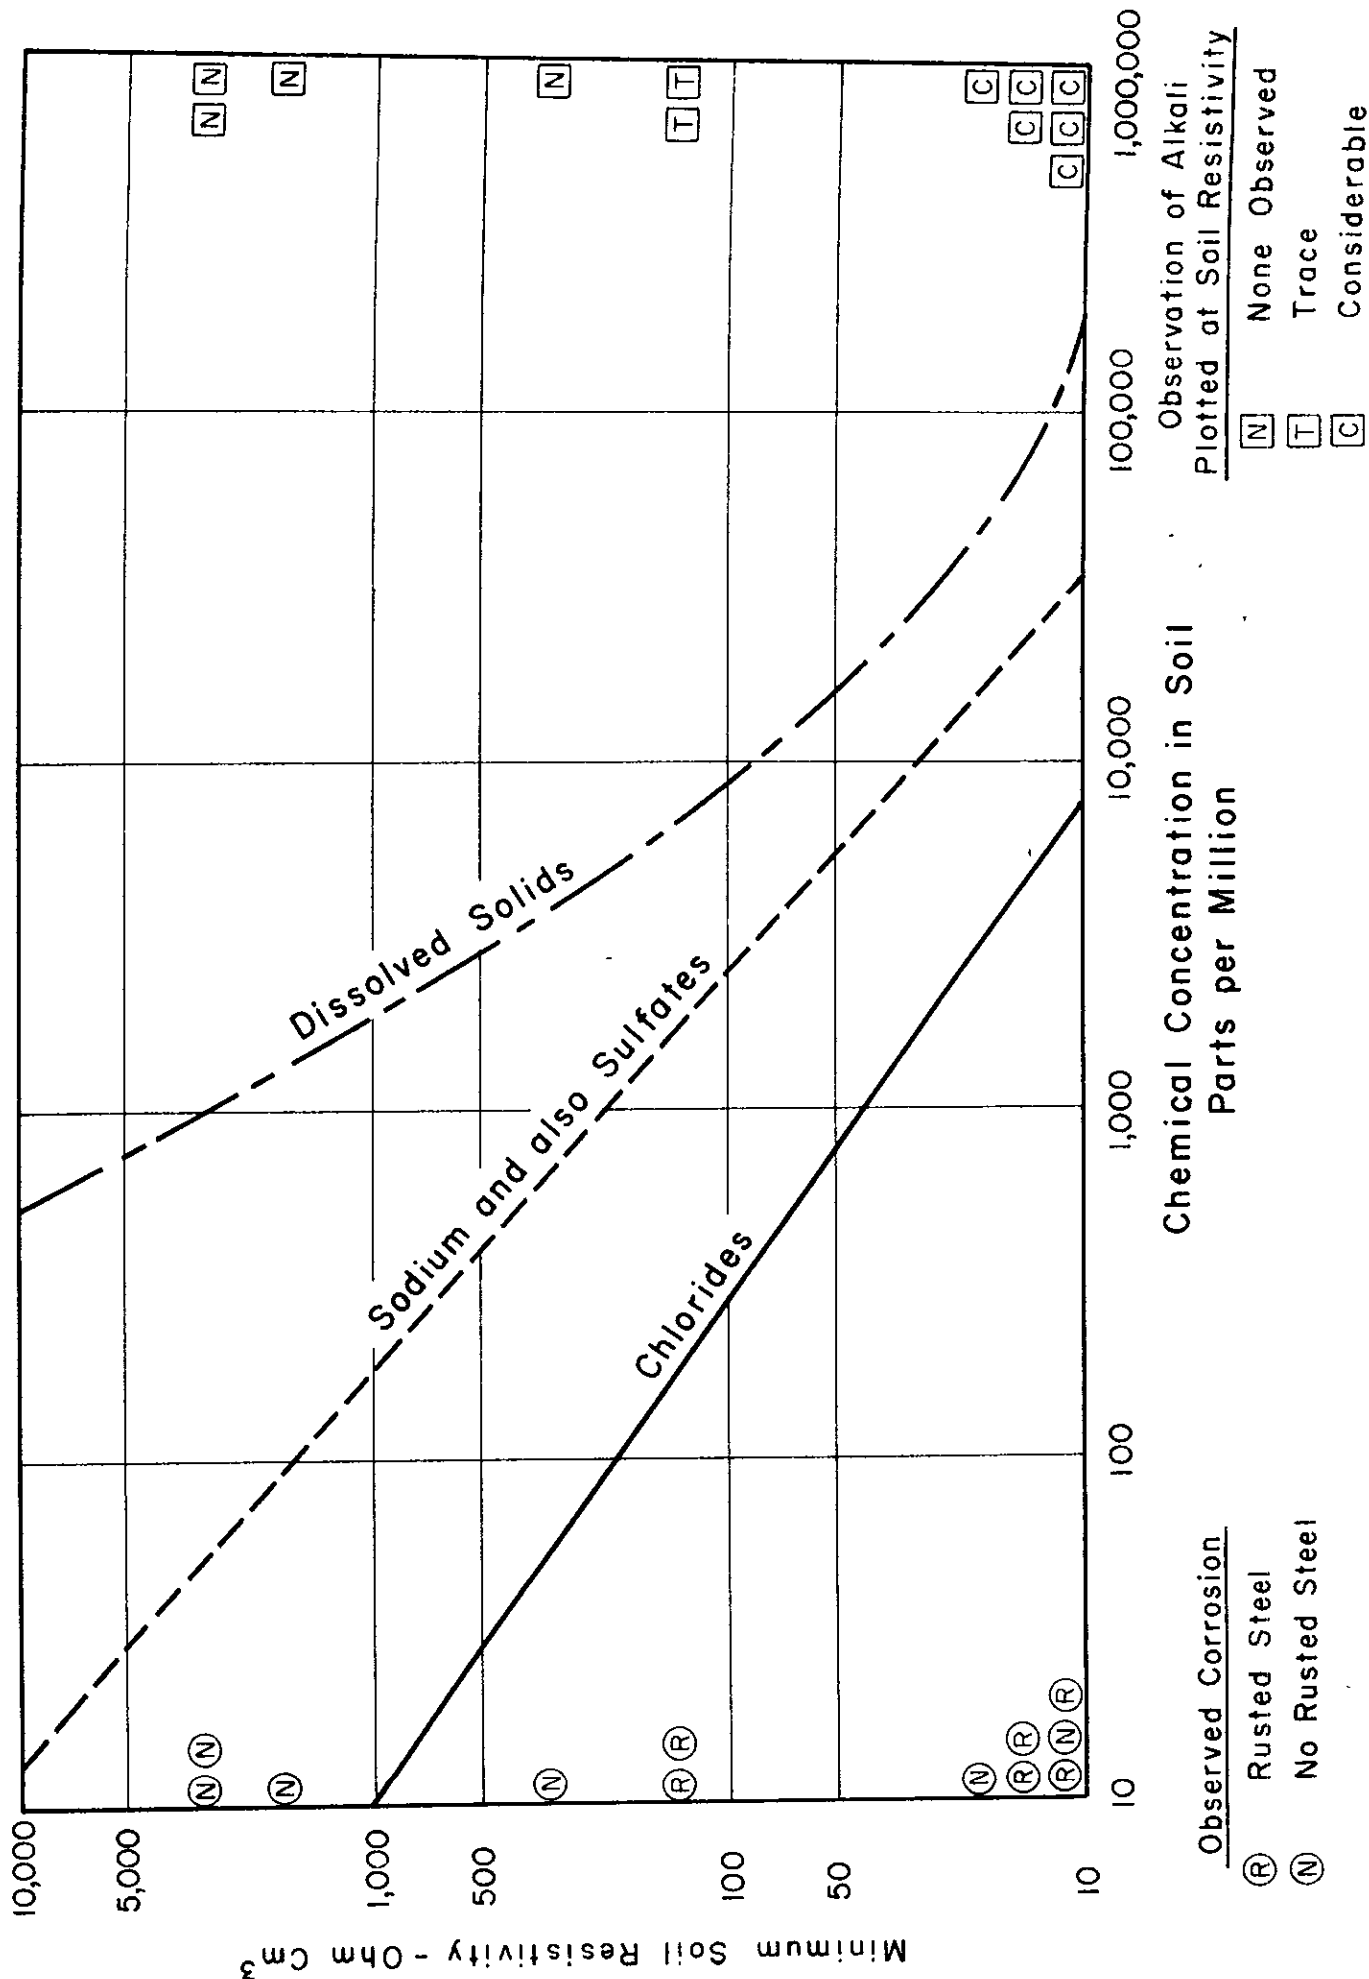
CHEMICAL ANALYSIS OF SOILS PLOTTED AGAINST MINIMUM SOIL RESISTIVITY

As will be noted on Exhibit IV and Table II, there appears to be a definite relationship between the minimum soil resistivity and the concentrations of Chlorides, sodium, sulfates and dissolved solids. Because of the few samples, it cannot be assumed that this apparent correlation is necessarily true for soils in other areas of the State.

Also included on Exhibit IV, is the observation of alkali deposits on the channel plotted at the measured minimum soil resistivity. From this exhibit, it could be inferred that when a trace of either white or black alkali is observed on the soil, that the minimum soil resistivity will be in the neighborhood of 200 ohm cm. As a point of reference for these values, the resistivity of sea water is in the range of 50 to 100 ohm cm.

In this geographic area, alkali soils were found which have a minimum of approximately 100 ppm chlorides, 1000 ppm of sodium, 1000 ppm of sulfates and about 5000 ppm of dissolved solids. The potassium salts ranged between 8 to 1000 ppm and were not plotted as the data were too scattered to define a linear relationship between resistivity and potassium. However, as a rule of thumb, when the soil resistivity was less than 200 ohm cm the potassium varied from approximately 100 ppm to 1000ppm. When the soil resistivity was in excess of 200 ohm cm the potassium concentration ranged from about 100 ppm at 200 ohm cm to 8 ppm at 8500 ohm cm.

Also included on Exhibit IV are notations indicating whether the reinforcing steel was rusted at the locations where the soil samples were obtained. Perhaps by chance, the indicated soil resistivity of 200 ohm cm again appears to be the limit where corrosion of reinforcing steel was observed. It would be no more than conjecture to state that 200 ohm cm may be the limit of anything, as there is no comparison based on time for any of these observations; and there is a possibility that corrosion may occur at a later date.
